NORTHWEST DRAIN (1996-2000)
Tuscola County, Michigan
Drain Commissioner, Sarah M. Pistro

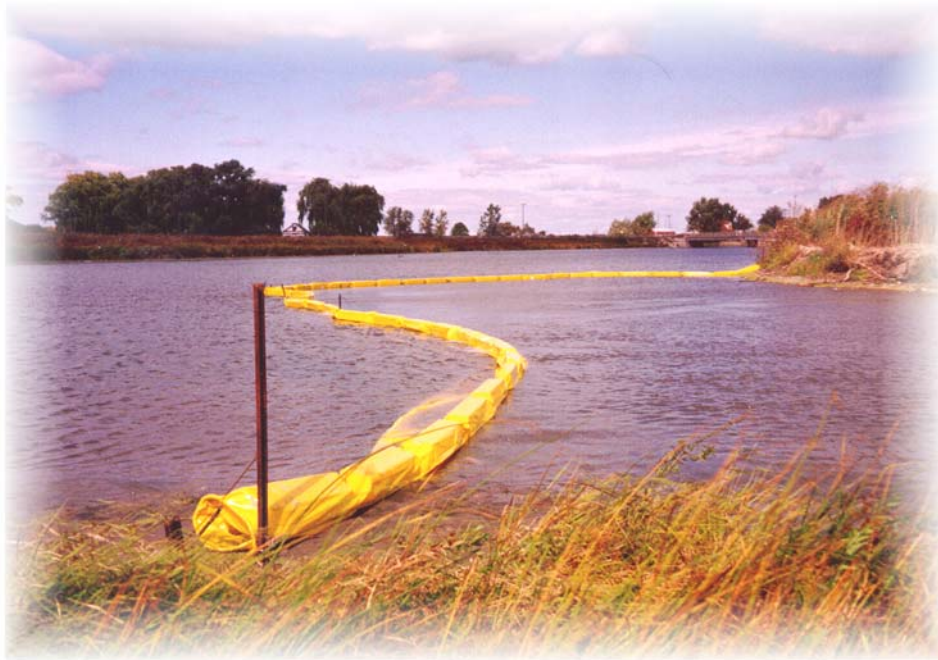
Outlet B was treated as an extension of Outlet No. 1 for the sake of design. The two outlets are continually in Bay water level influence. Additionally, considerable wetland and marsh area provides more than adequate flood storage. The channel, marshland and farmland provide significant habitat for fisheries and birds. It was important in the design of this area that dredging be isolated from the undisturbed areas. In response to this, the channel was dammed off from the Quanicassee and dredged in dry conditions. A submerged outlet was proposed in the Quanicassee and a floating curtain barrier was installed at the mouth of Outlet B while construction commenced.

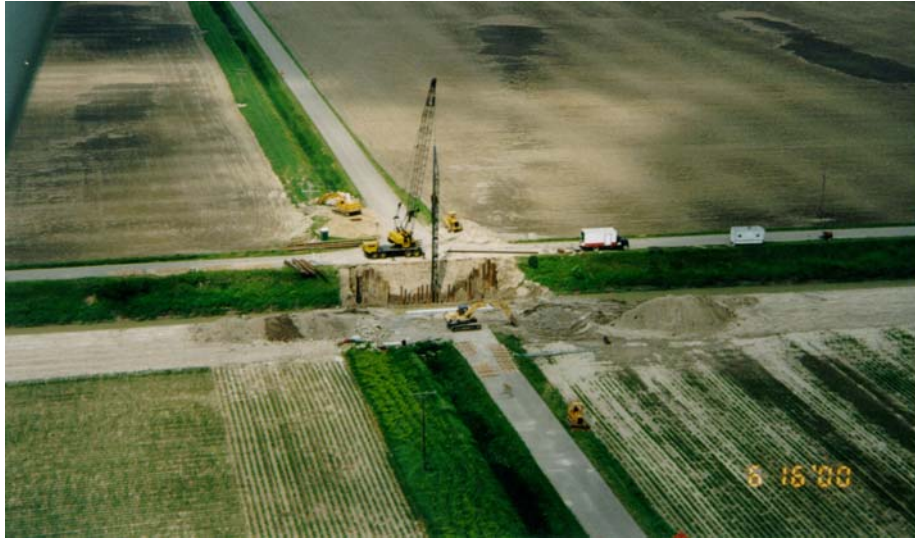
The improvement of bridge infrastructure along the length of the project eventually required the replacement of twenty-seven crossings. Fourteen of those were bridges of 44 feet of clear span or larger. Thirteen of those fourteen bridges were built using concrete abutments over a deep piling foundation with a deck comprised of pre-stressed concrete box beams. Eleven of these thirteen were private bridge crossings that provide access to farmland directly from a county road. The remaining two were county road crossings over Outlets 1 and 3.

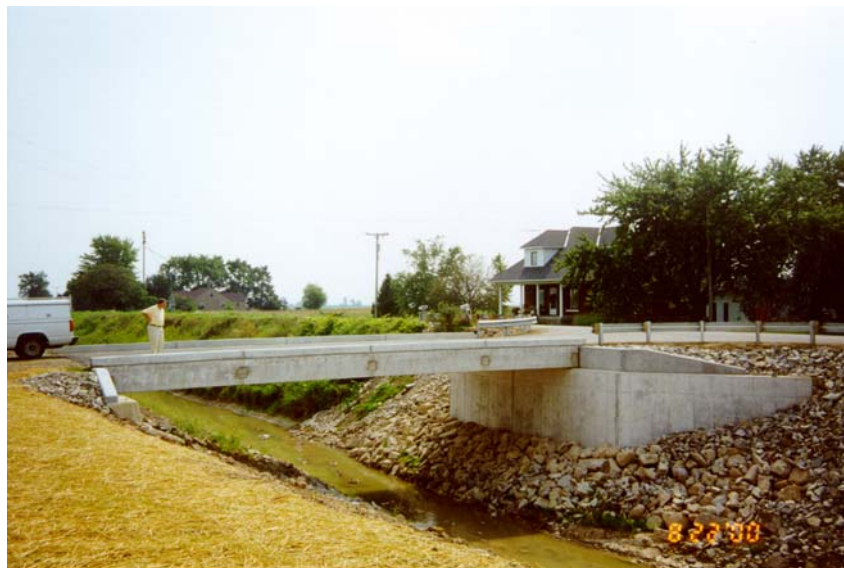
The requirements for farm bridges along the roads eventually led to designs which incorporated the need to protect traffic from leaving the roadway near the abutments and a wide enough turning radius for farm equipment and trucks to enter the crossings from the narrow, elevated roadways which exist along the Northwest Drain. Guardrail on the approaches to the bridges was used along with a 24 foot bridge roadway width and low rails on the deck to achieve the clear area required for the large custom equipment common to the district. The road bridges were constructed to Tuscola County Road Commission requirements using 1990 MDOT Specifications.

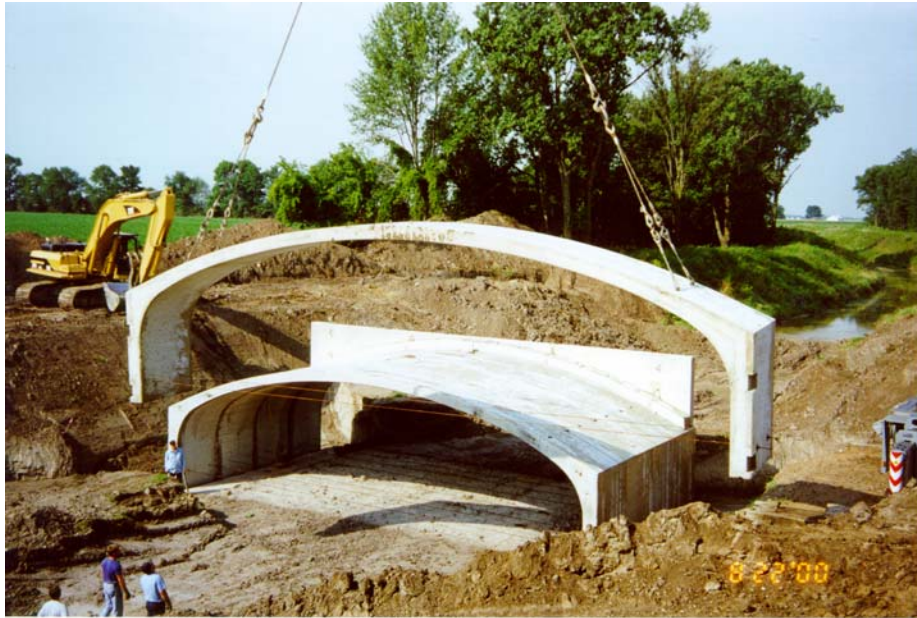
The landowner, Jeffery Shian, had inquired with the drain office if it was possible to construct an access bridge at this site because he was frequently cut off from his property by deep flows in the main channel. The water remained deep for long enough some years to significantly delay planting. A solution was found in a new structure offered by Premarc. This pre-cast structure known as a CON/SPAN offered the dual advantage of a pre-engineered, pre-cast culvert that could be installed with relative ease at a lower cost than conventionally constructed bridges. The largest span available, a 48 foot span culvert, when modeled, was found to fit the requirements at the Shian property.

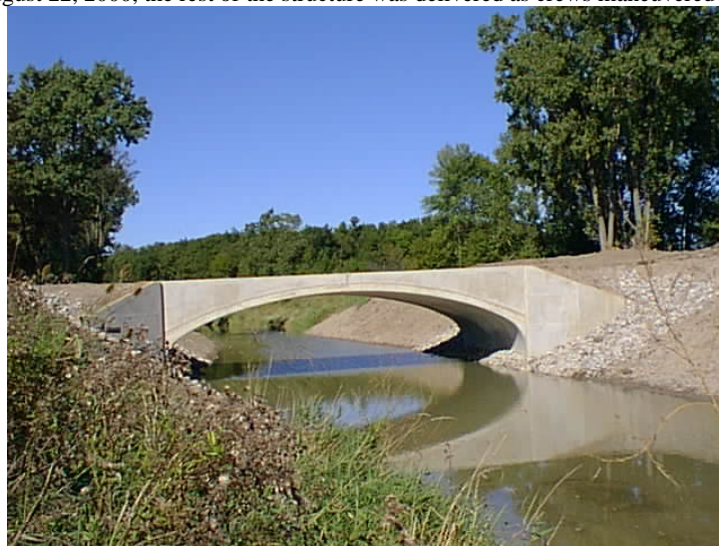
Massive concrete footings were laid out by a BMJ survey crew and installed by the contractor several weeks prior to delivery of the precast structure. A diversion channel was constructed to maintain the flow of water around the construction area. Several precast arch sections were delivered from Grand Rapids, Michigan late on August 21, 2000 and were set in place as they were unloaded. On Tuesday August 22, 2000, the rest of the structure was delivered as crews maneuvered the sections into place.

Five 35 ton arches were placed while four sections completing the head walls and weighing 8 tons per piece were attached. Finally four massive wingwalls weighing 16 tons each were installed on the structure. The entire operation of constructing the bridge from the time delivery began to the last wingwall in place took approximately one day. In all, 271 tons of precast concrete
